February 2004
Exterior Building Conditions Inspection Report:
Laurel Train Station Building
Laurel, DE

Philip E. Franks
Hurley-Franks & Associates
HFA Project # 2003.010

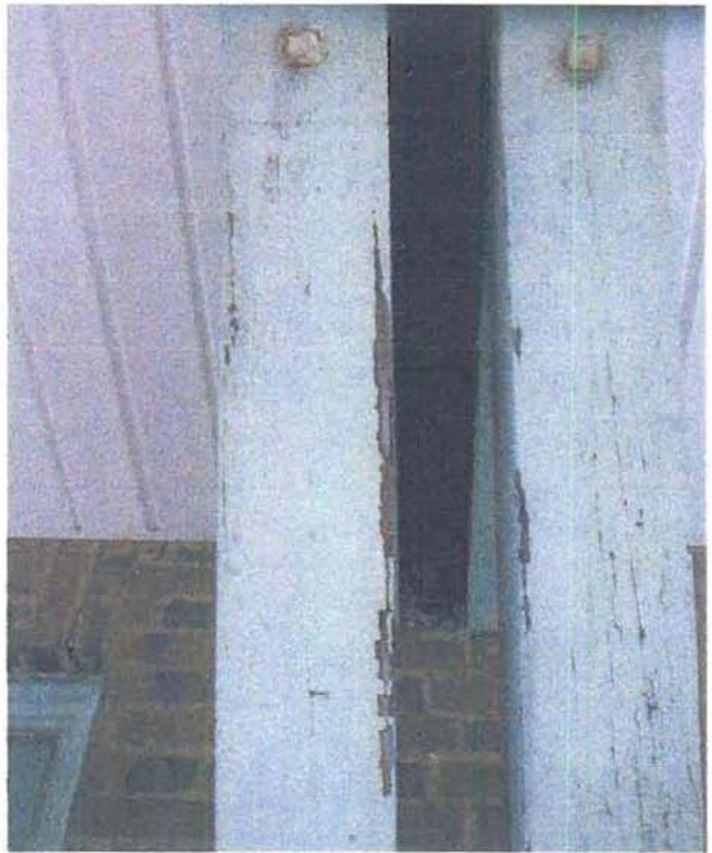
Photo-10

The condition of the overhanging soffit is undetermined. The soffit is entirely covered with vinyl soffit material. The original soffit, where it can be barely glimpsed through the 2" spaces between the over hanging support brackets on either side of the Platform Station Ticket window, appears to be wood bead board painted to match the green paint on other exterior painted surfaces of the building. (See Photo 10) Given the fact that the soffit is covered with vinyl soffit material makes me suspicious that it was installed so as to eliminate the need for any further attention to repairing and repainting of damaged soffit areas.

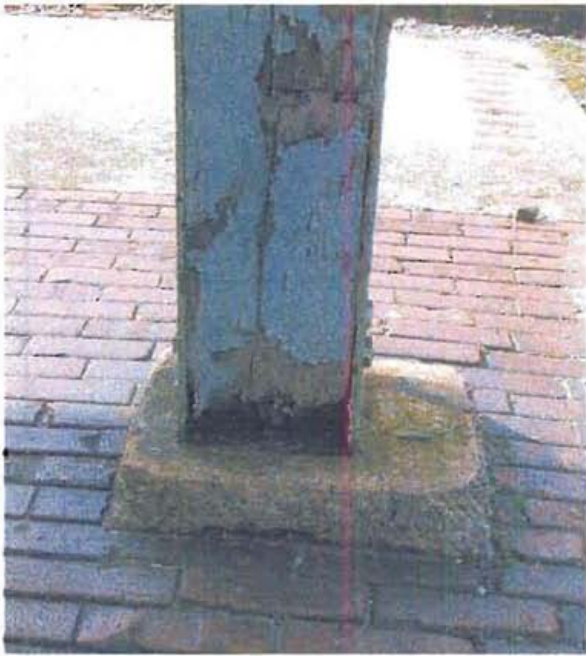
Photo-12

There are three exterior structural wood posts along the exterior platform. These posts are wood timbers measuring approximately 7" square. These posts are attached at the platform level with steel brackets which themselves extend from concrete foundation stems, stems which themselves extend approximately 2" above the platform surface. The two end column stems have storm drain boots cast into them. Both boots are currently filled with concrete. (See Photos 12, 13, 14 & 15) Roof conductors now discharge roof water directly onto the top of the stem or onto the surrounding brick platform. They are not tied into any storm drainage system.

One of the wood posts clearly needs repair at its bottom. Years of neglect have contributed to its rotting condition. One corner of one of the concrete stems has broken off exposing the badly rusted steel post connectors. These broken stems, rusting steel post connectors and the rotting wood posts need repair soon. While none of these conditions warrant alarm about the structural integrity of the building, to leave these items unattended is to invite serious problems in the future.
